NWC TP 4738

# SAFETY TESTS OF EXPLOSIVES TRANSPORT TRUCKS

## NAVAL WEAPONS CENTER

CHINA LAKE, CALIFORNIA \* JULY 1969

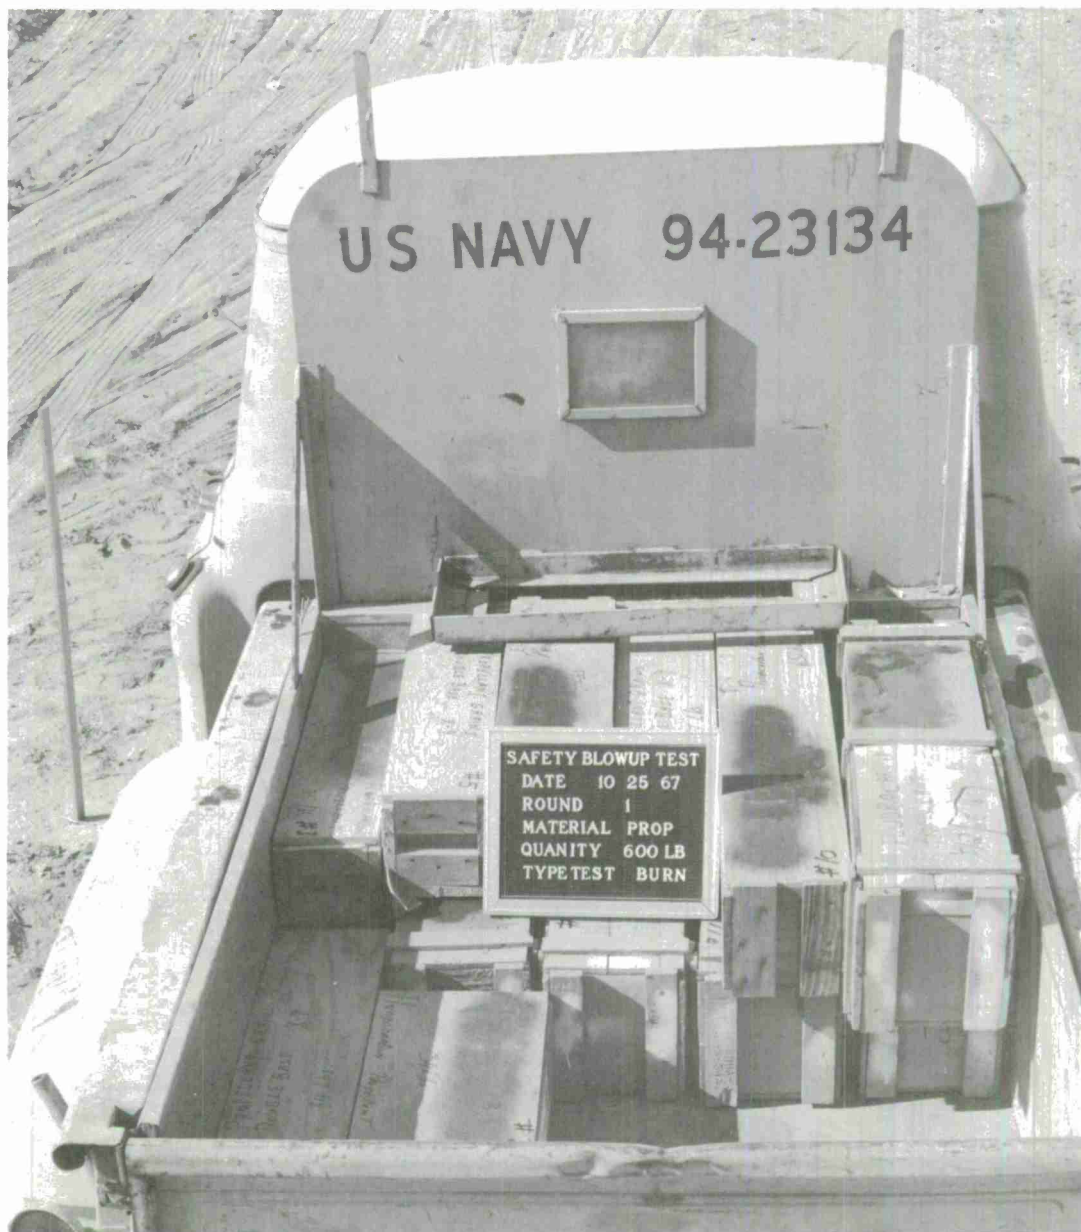
For this test of the hazards of burning propellant to a truck and its occupants, 600 pounds of bulk double-base and fluorocarbon propellants in wooden boxes with lids were placed at random on a truck bed and ignited (Fig. 1 and 2).

FIG. 2. Boxed Bulk Propellant Loaded on Truck Bed for Burning, Test 1.

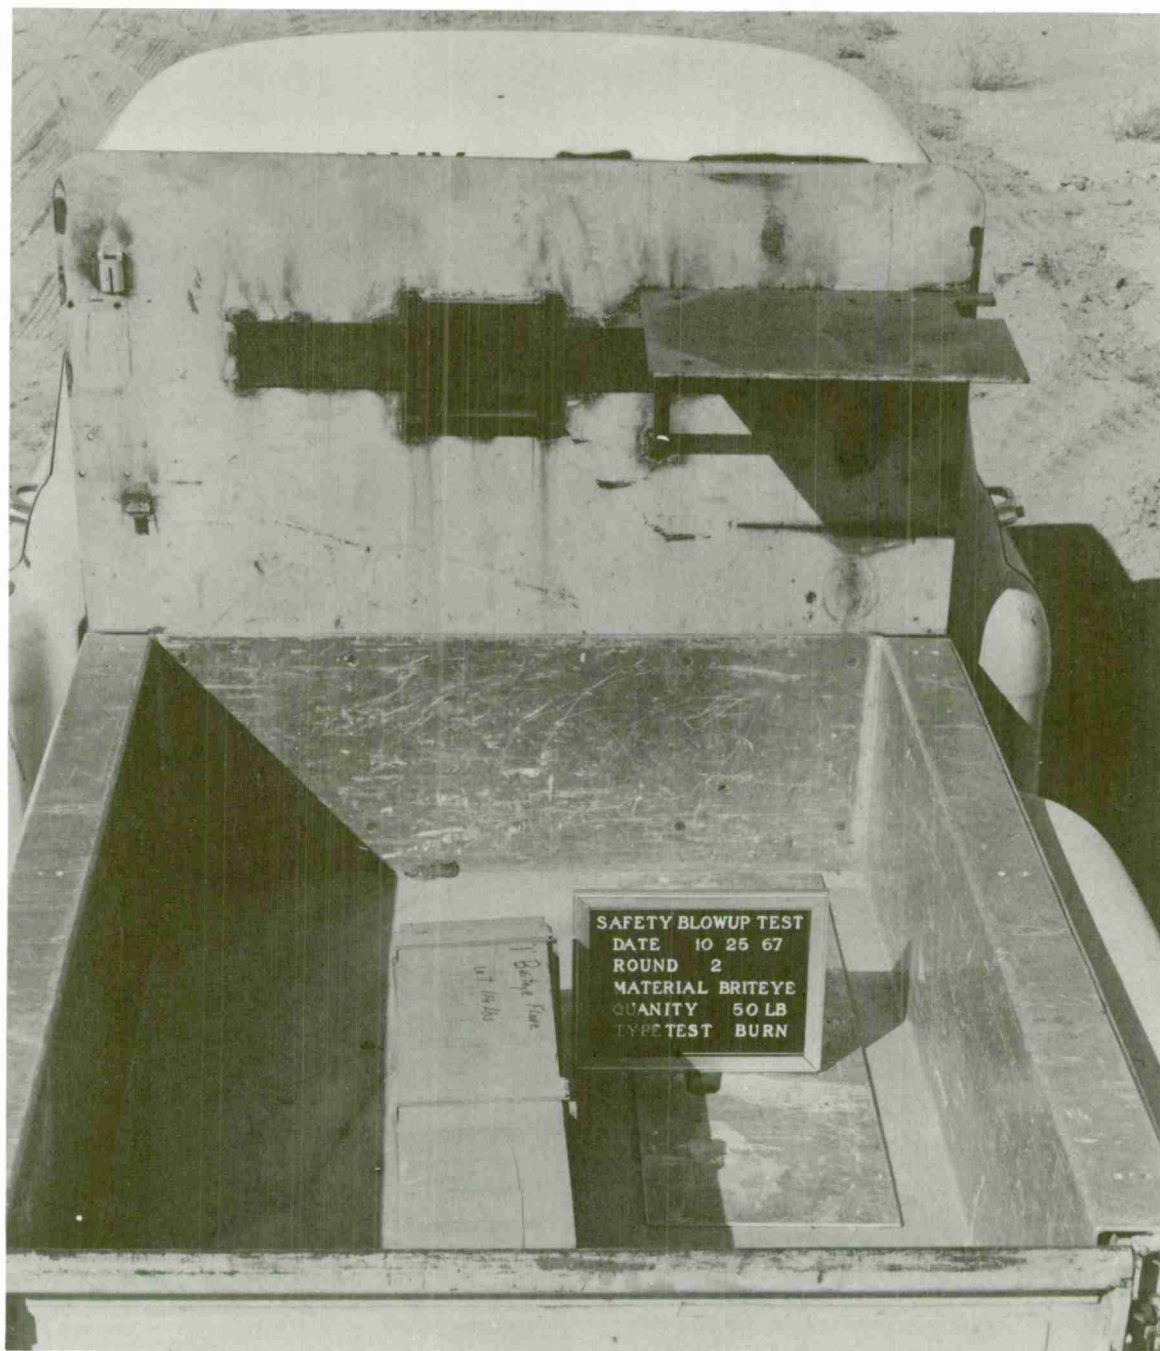
Test 2 was a burning test of 50 pounds of pyrotechnic material, that is, one Briteye flare candle in a wooden box placed near the rear of the truck bed in the normal hauling location (Fig. 5).

FIG. 5. Truck Loaded With 50-Pound Flare for Test 2.

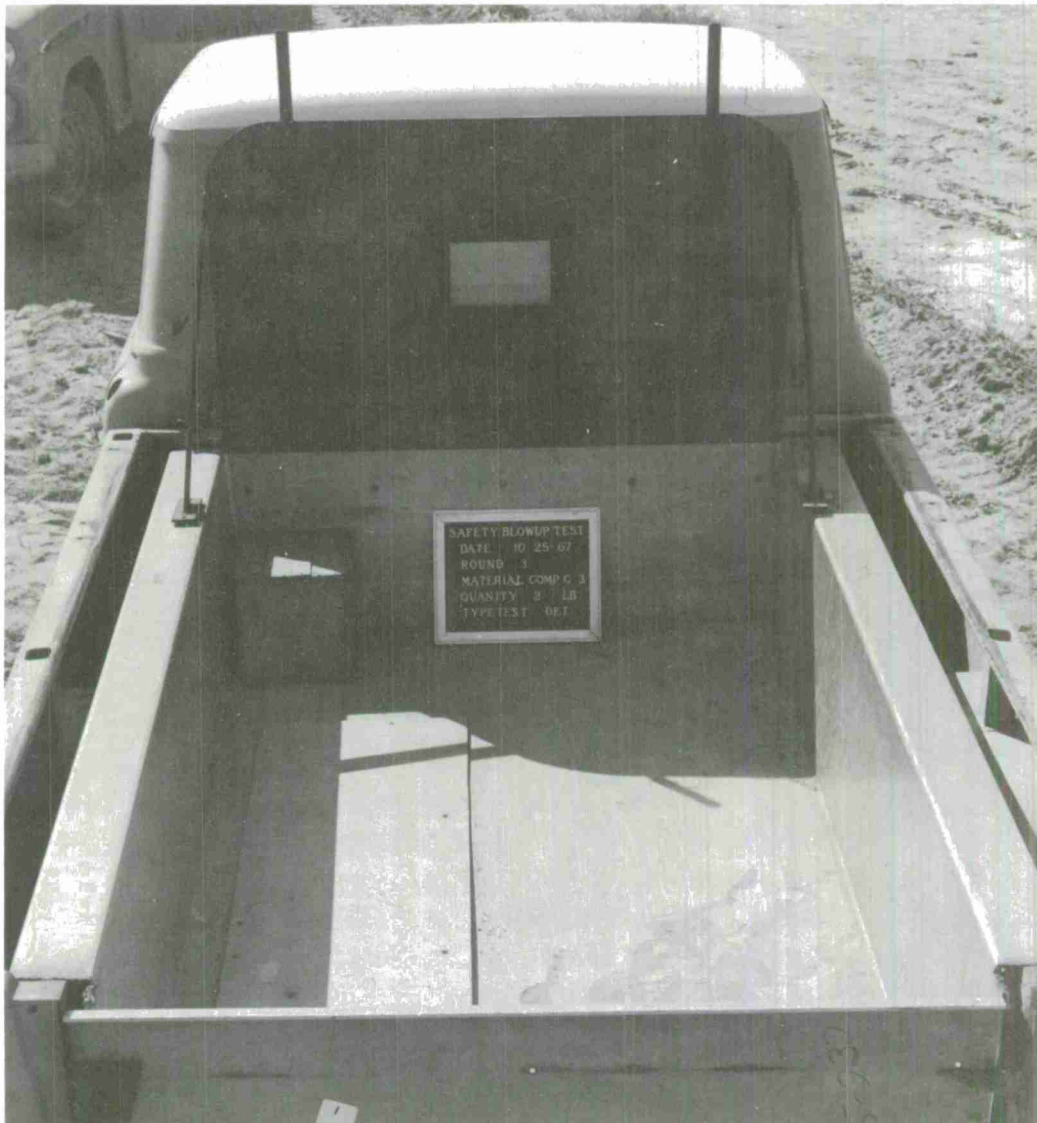
Test 3 was a detonation test in which a 2-pound demolition block of Composition C-3 in a wooden box was placed on the bed of the truck just behind the driver (Fig. 9).

FIG. 9. Truck Bed With 2-Pound Block of Composition C-3 in Place for Test 3.

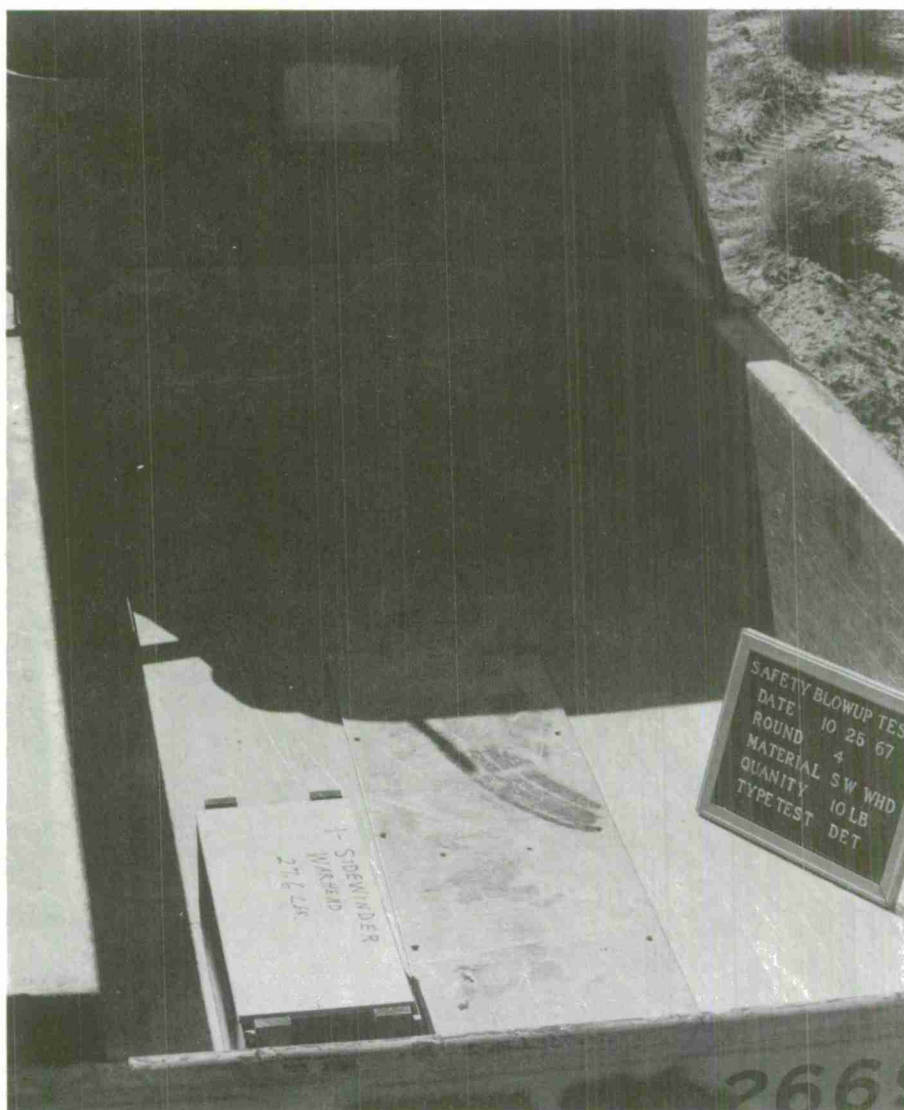
For Test 4, a detonation test, a wooden box containing a Sidewinder high explosives (HE) fragmentation warhead loaded with 10 pounds of Composition C-3 was put in place near the rear of the truck bed (Fig. 13).

FIG. 13. Fragmentation Warhead in Truck for Test 4.

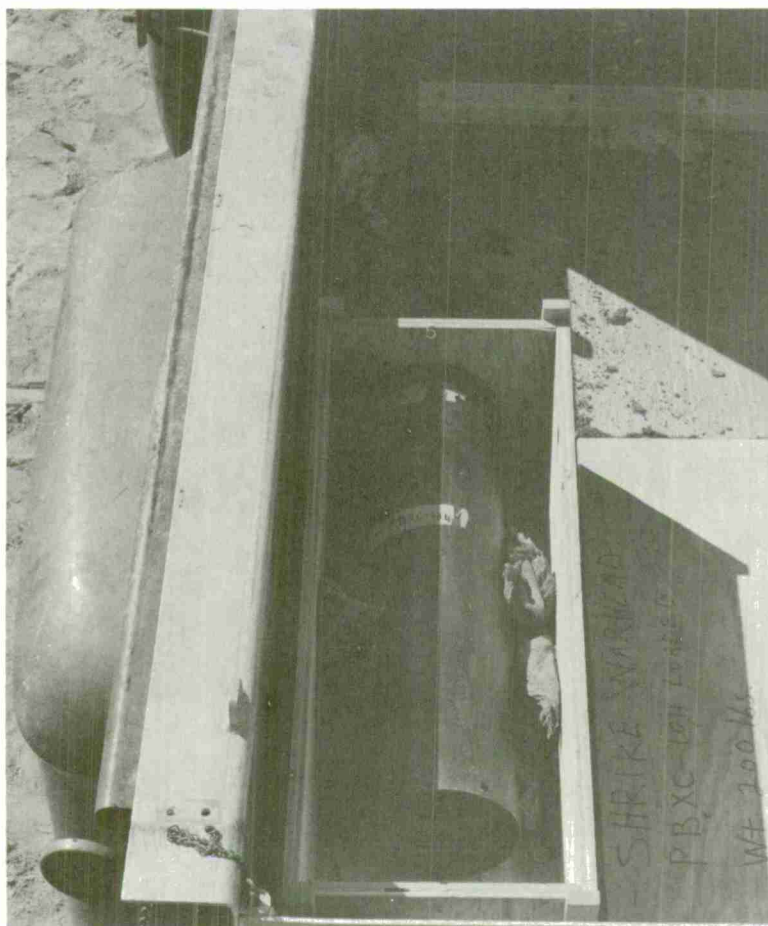
For Test 5, a detonation test, a Shrike fragmentation warhead loaded with 50 pounds of PBXC-104 and placed in a wooden box was located near the rear of the truck bed (Fig. 17).

FIG. 17. Truck Loaded for Test 5.
